Subject: Revised Root Cause Investigation – Diesel Generator Amphenol Connector
Cooper Nuclear Station, Docket No. 50-298, DPR-46

Root Cause Investigation (Rev. 1)
Unexpected DG-2 Shutdown
CR-CNS-2008-00304
Dated 7/11/2008

ROOT CAUSE INVESTIGATION (REV. 1)

UNEXPECTED DG-2 SHUTDOWN CR-CNS-2008-00304

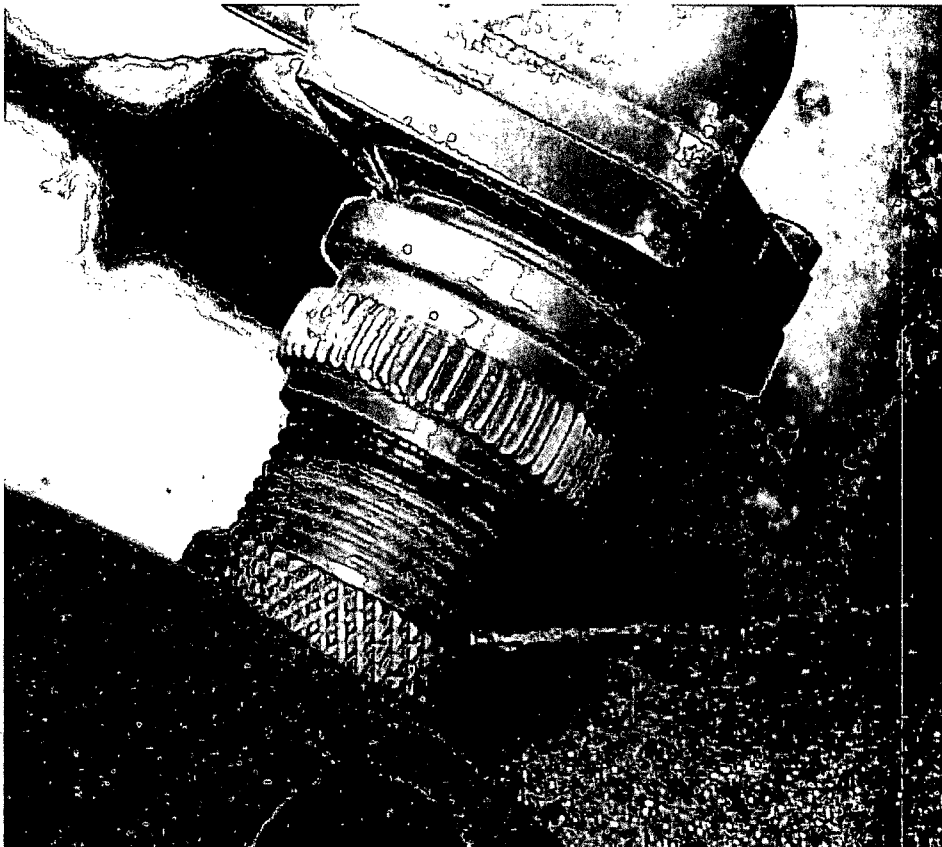
After the unexpected DG2 shutdown, an FMEA was generated (see Appendix A) which was used to develop a troubleshooting plan. The resulting troubleshooting performed on 1-16-08 identified a loose amphenol-type connector to the relay tachometer speed sensor (DG-SE-3143). The as-found condition was as follows:

- The coupling nut was observed to be engaged $\sim\frac{1}{4}$ turn (compared to an additional ~ 5 turns to full engagement/tight). Note that there were differing recollections of the as-found connector ring engagement from the technicians that were present. No measurement was taken.
- The connection was felt to be loose when manually manipulated
- Resistance measurements showed instability when the connector was moved

The loose relay tachometer speed sensor connection is deemed to be the failure mode that resulted in the unexpected DG2 shutdown based on the following:

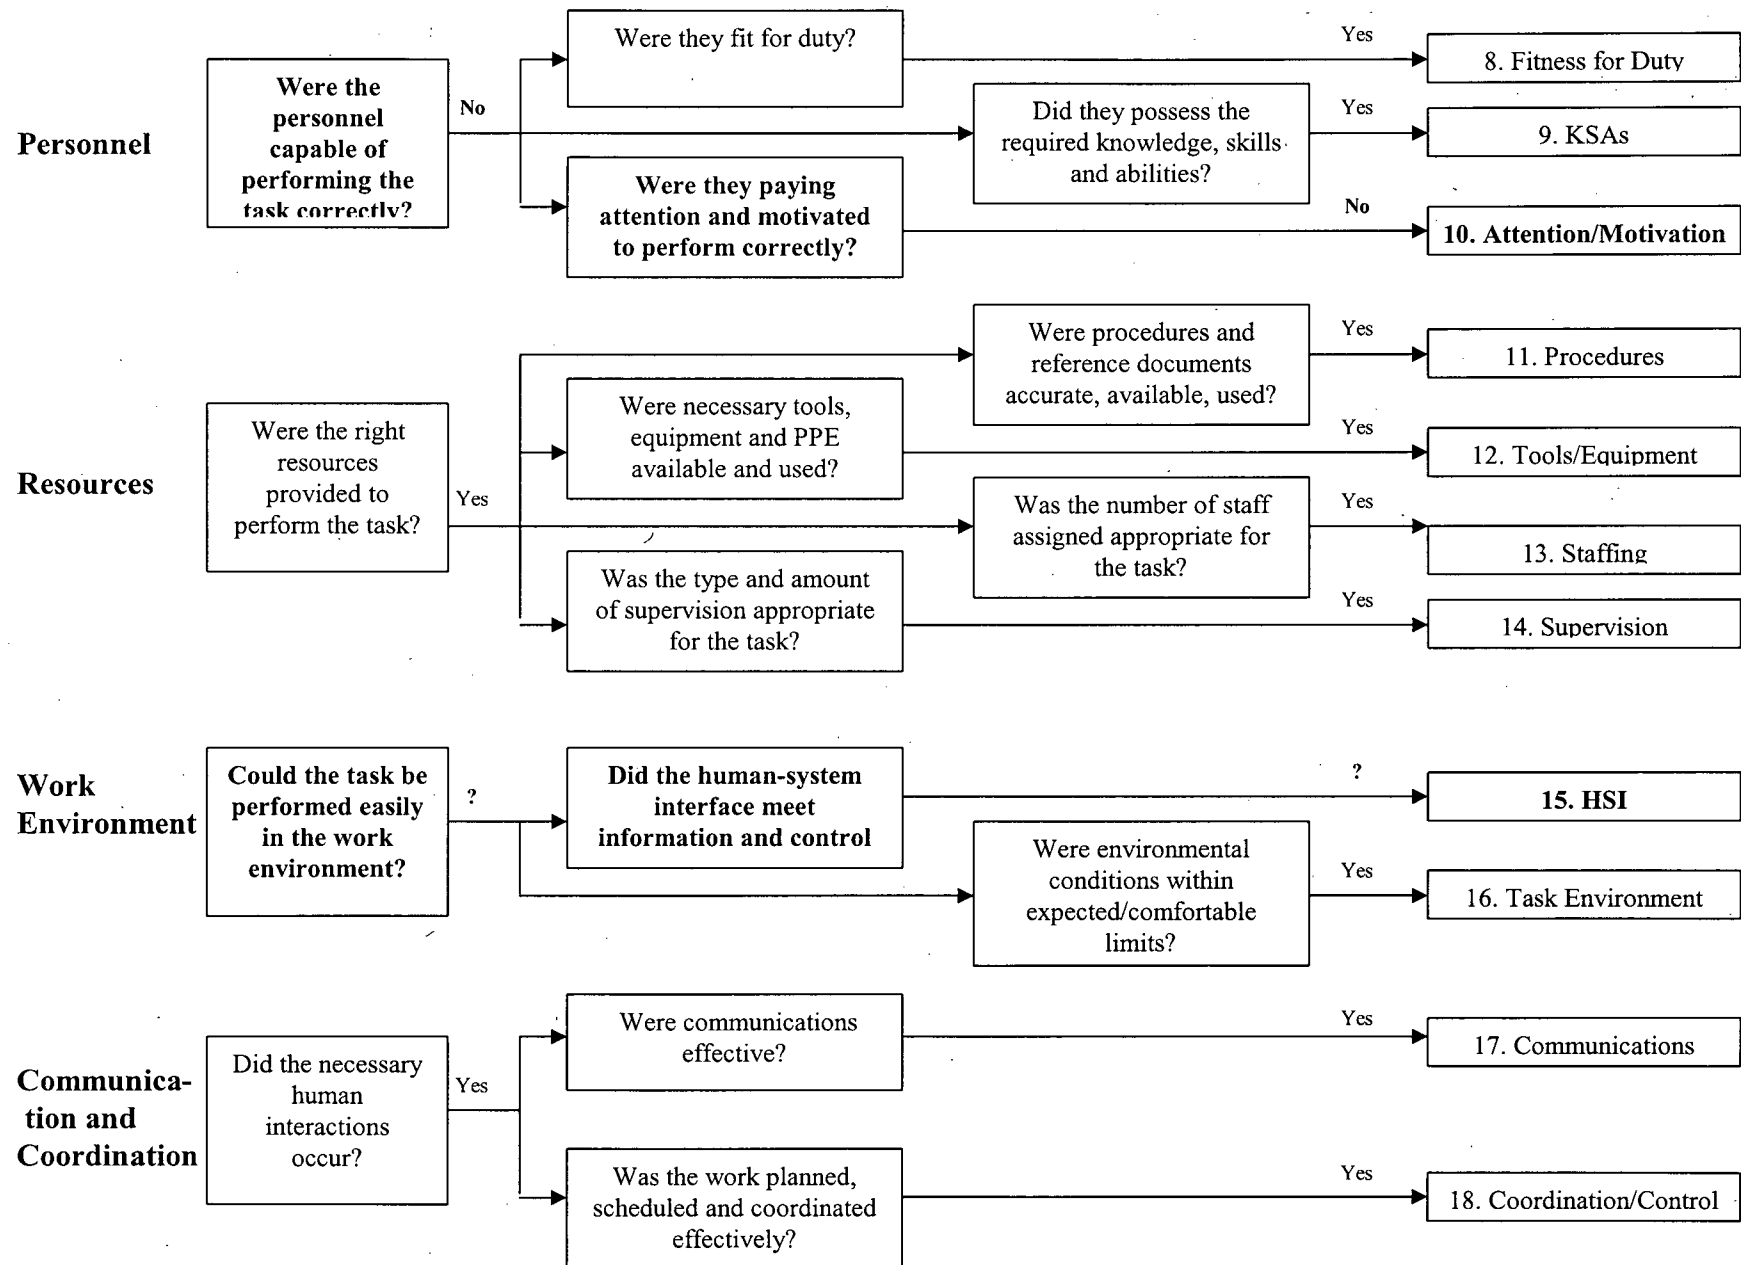
Figure 7-1 The HPEP Cause Tree

Resources - The task did not involve special tools or oversight, therefore this path is not considered applicable.

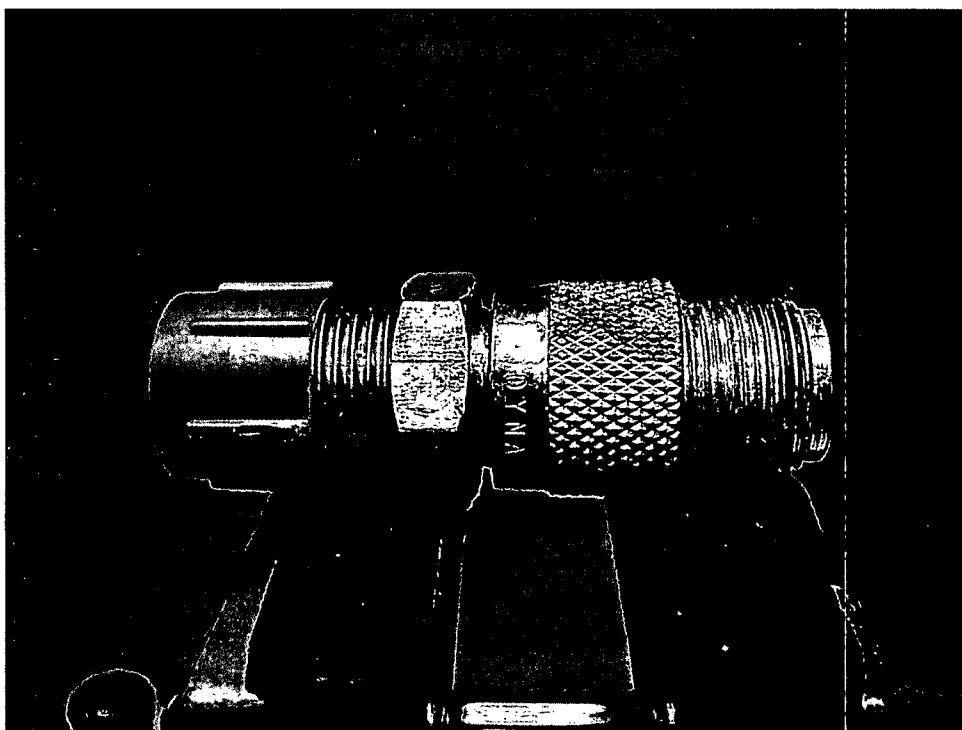
Figure 1. M101 MPU Removed from DG #2

A visual inspection of the connector threads of the relay tachometer MPU removed from DG #2 was performed. The threads showed no noticeable signs of damage or significant wear. The threads were coated with a black material presumed to be Loctite which was wiped off prior to inspection. Figures 1 and 2 below show the M101 MPU and a close up of the connector threads.

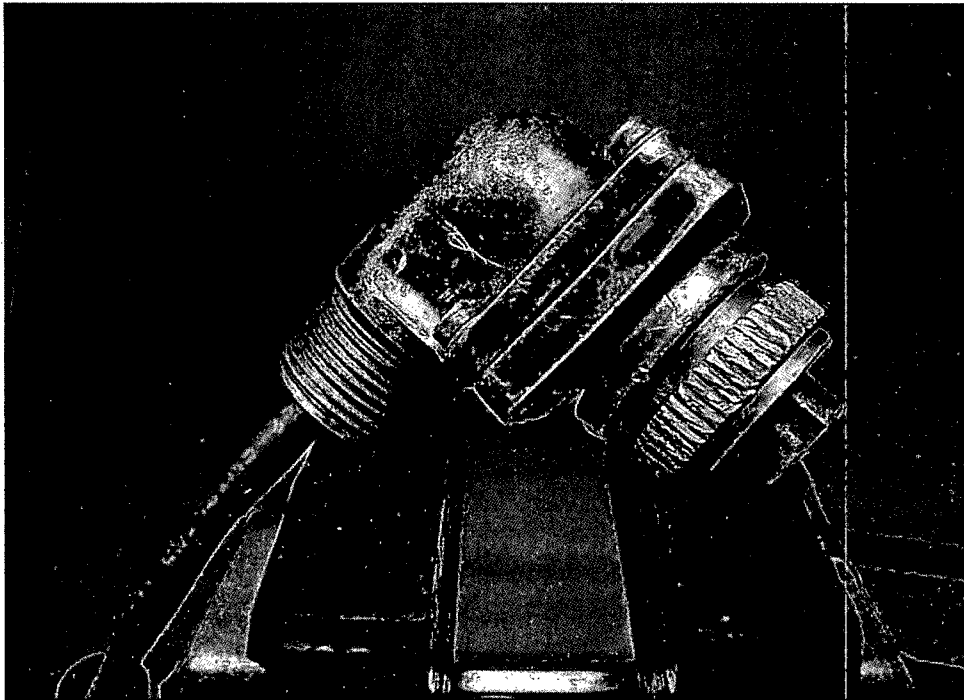
A visual inspection of the MS 3108A-10SL-4S connector removed from DG #2 was performed. The exterior of the connector shows obvious tool marks on the connector collar as well as other scratches. Some signs of wear are also evident on the socket sleeve which attaches to the MPU. None of the damage appeared significant enough to affect the electrical function of the connector. However, the signs of wear on the socket could contribute to making the connector attach less tightly to the MPU. The connector was plugged in and removed from the M101 MPU several times to gauge the tightness of this connection and it was found to be rather tight. That is to say, it seems very unlikely that the connector would fall off the MPU under its own weight. Inspection of the threads in the interior of the connector collar showed no signs of damage of significant wear. Figures 3 and 4 below show close up views of the MS 3108A-10SL-4S connector.

Figure 3. MS 3108A-10SL-4S Connector Removed from DG #2 (A cable was attached prior to taking this picture)

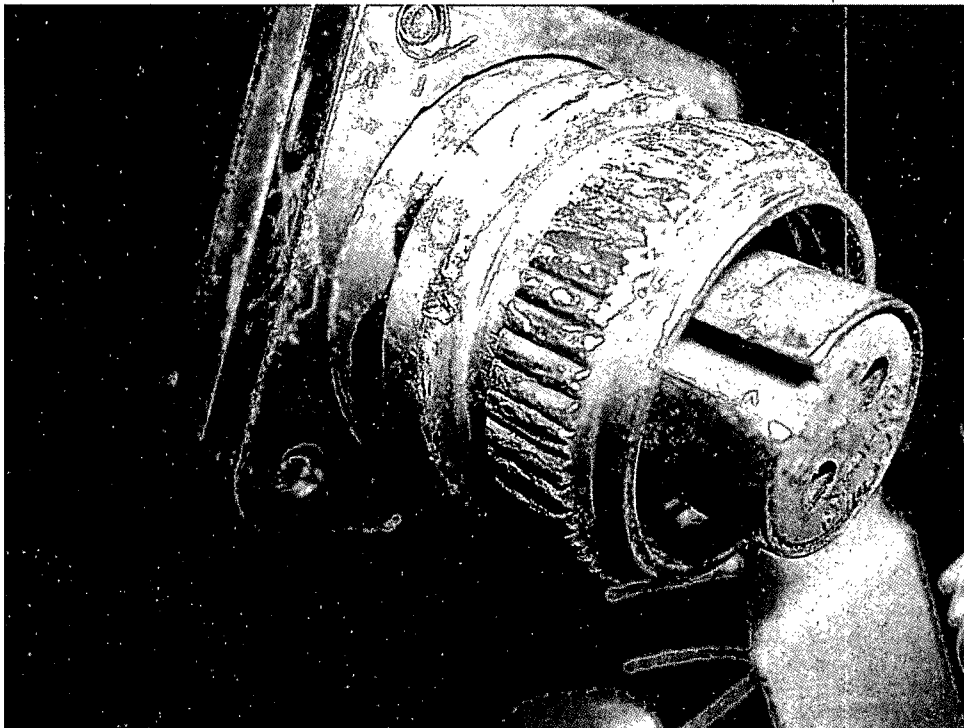
Figure 4. MS 3108A-10SL-4S Connector Removed from DG #2 (Close up of collar and socket showing tool marks and wear)
